Pavement Rehabilitation Manual

VOLUME I: PAVEMENT EVALUATION

**MATERIALS BUREAU
NEW YORK STATE DEPARTMENT OF TRANSPORTATION**
Mario M. Cuomo, Governor/Franklin E. White, Commissioner

M.A.P. Code 742-4-4
June 1990
Revised February 1992

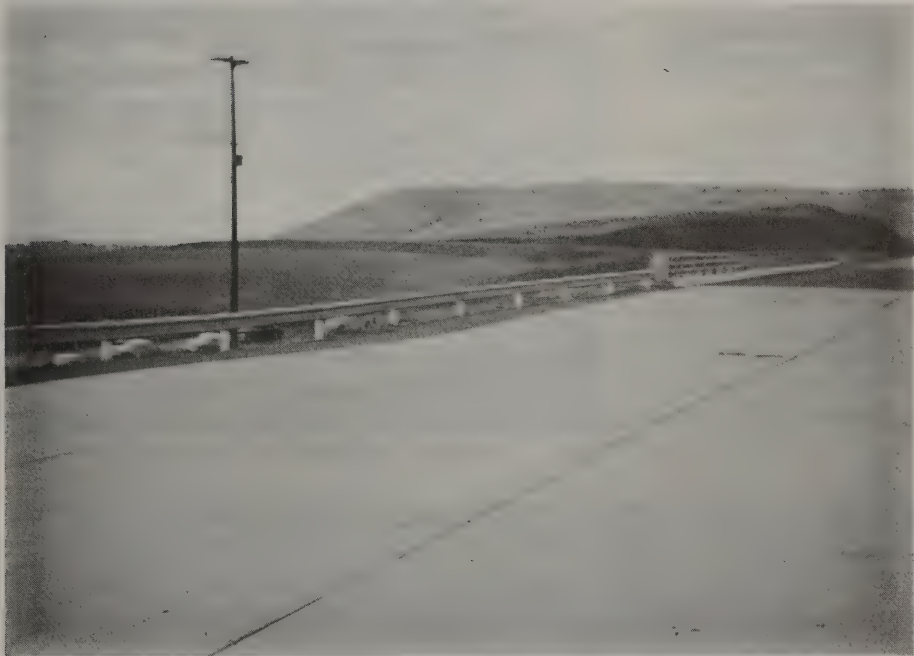
Figure B1 - Settlements and Heaves

Typical Bridge Approach Settlement

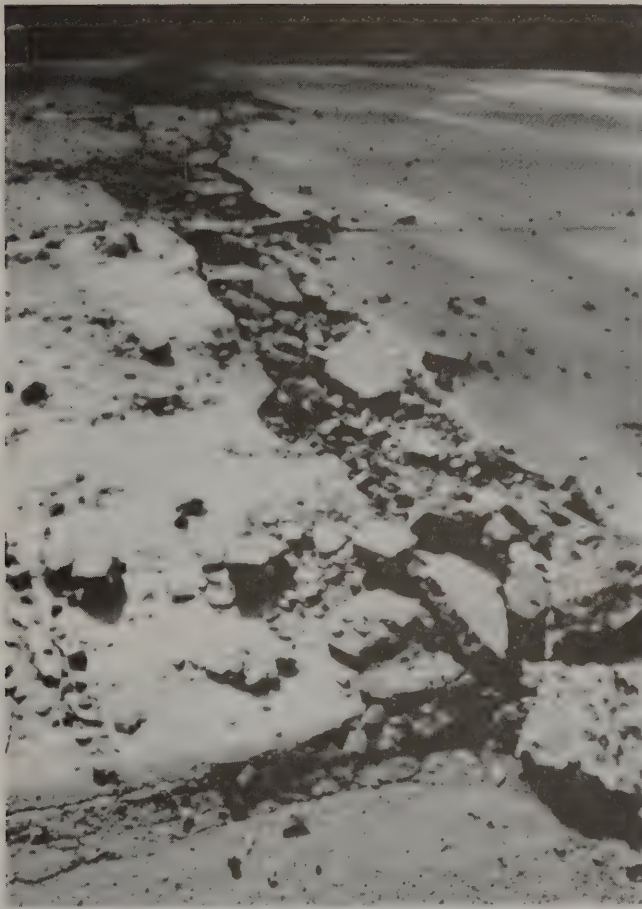
Figure B2 - Blowups

A localized buckling or shattering of a slab generally occurring at a transverse joint or crack which may or may not have been patched with bituminous concrete.
(Figure B2)

Blowup Showing
Shattered Concrete
Before Repair

An infiltration of fines in unsealed transverse joints which acts as an incompressible medium. This incompressible medium will buildup due to the normal contraction which takes place in cold weather and the infiltration of abrasive sand and roadway dirt. The normal expansion during warmer weather will cause compressive stresses which are relieved when the pavement buckles or shatters.

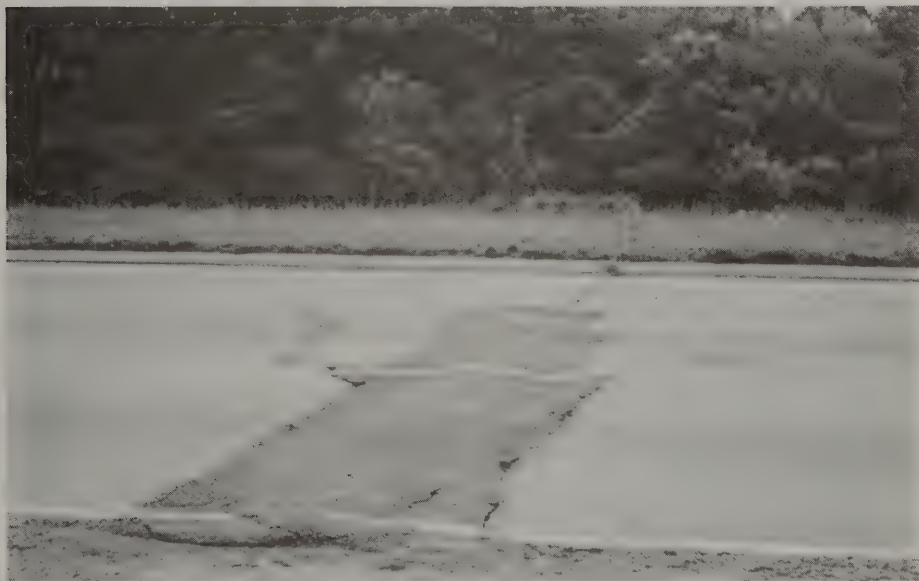
A partial width blowup occurs in one or some of the lanes of a multilane pavement. It does not extend across the full pavement width. Adjacent transverse joints will be seen to be misaligned as the slabs move toward the pressure relief caused by the blowup. A full width blowup occurs across the entire pavement width and does not cause transverse joint misalignment.

Partial Width Blowup That Occurred In The
Near Lanes Only And Has Been Repaired With
Asphalt Concrete

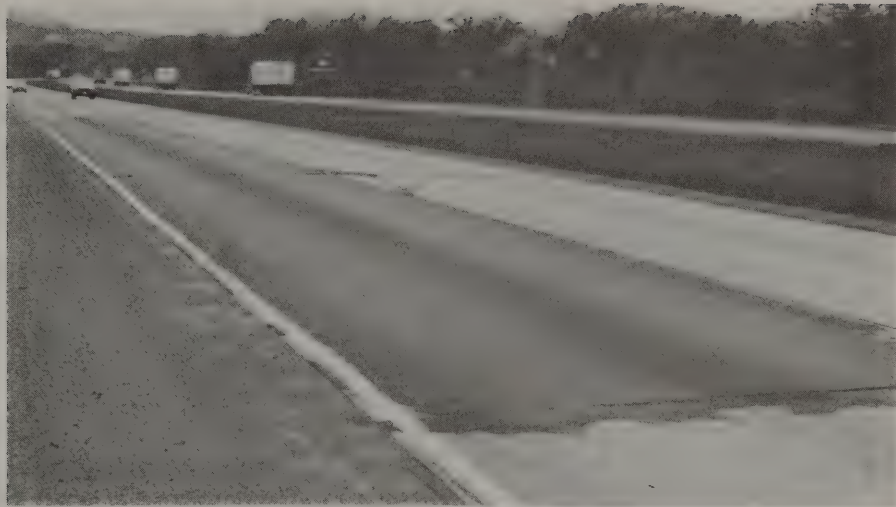
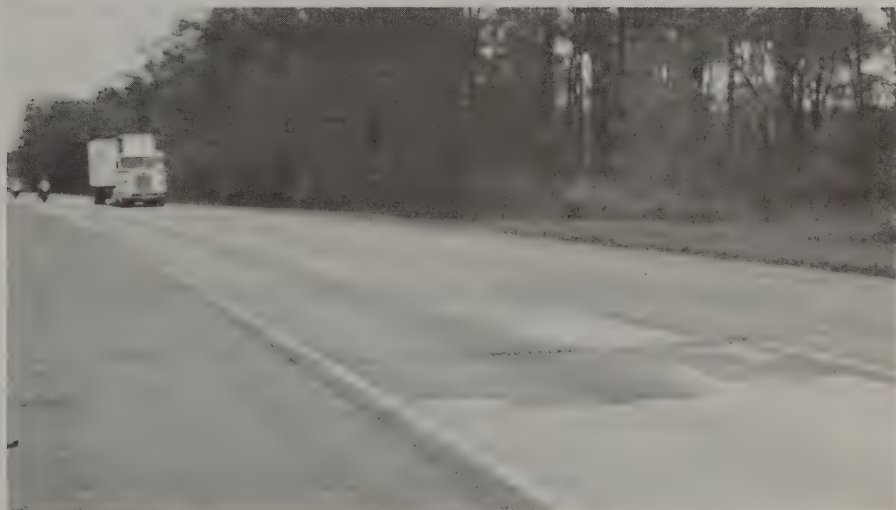
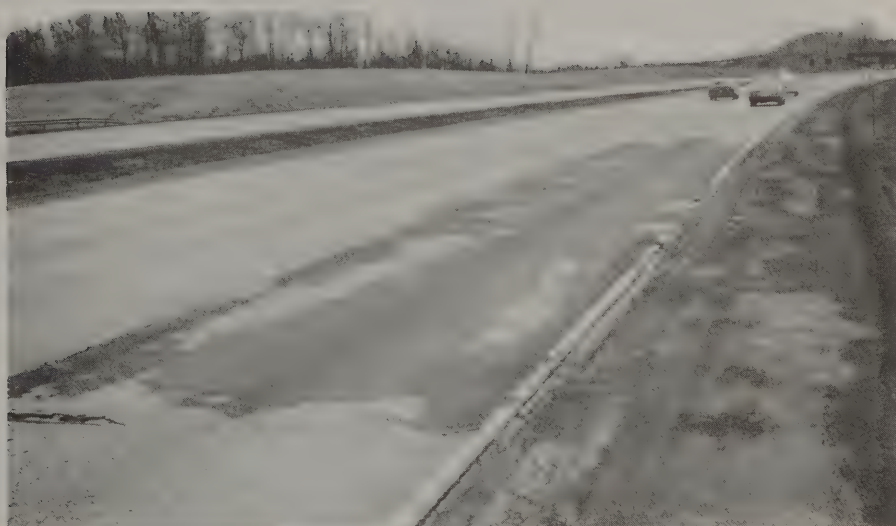
Figure B3 - Asphalt Concrete Overlay Patching

Good

Fair

Poor

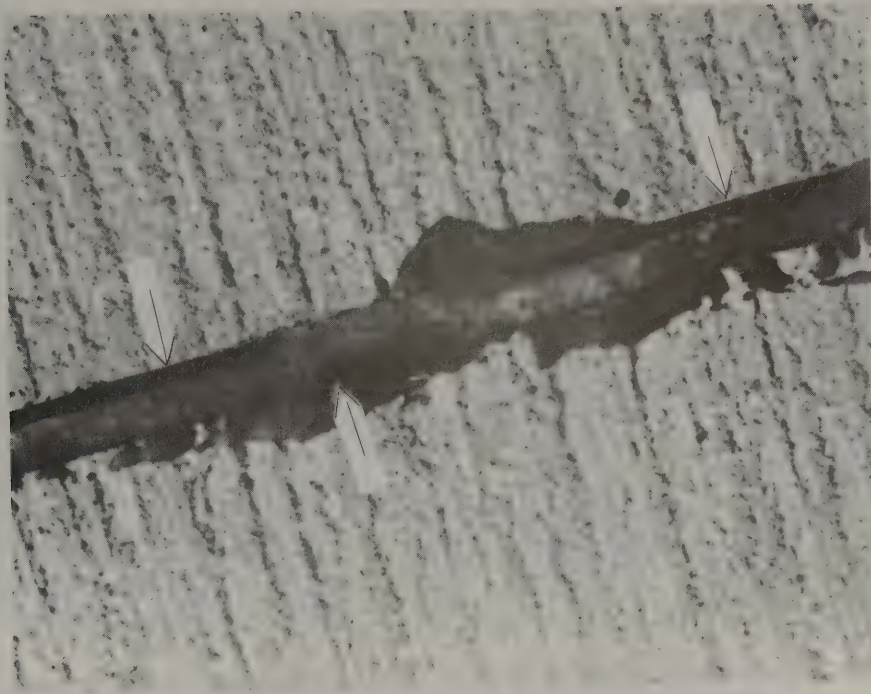
Liquid Sealer Adhesion Failure

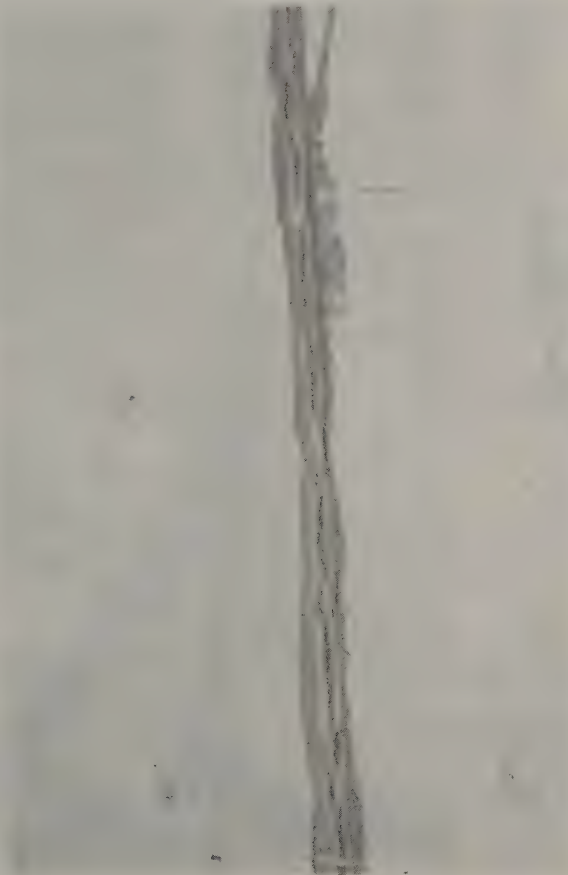
Liquid Sealer
Cohesion Failure

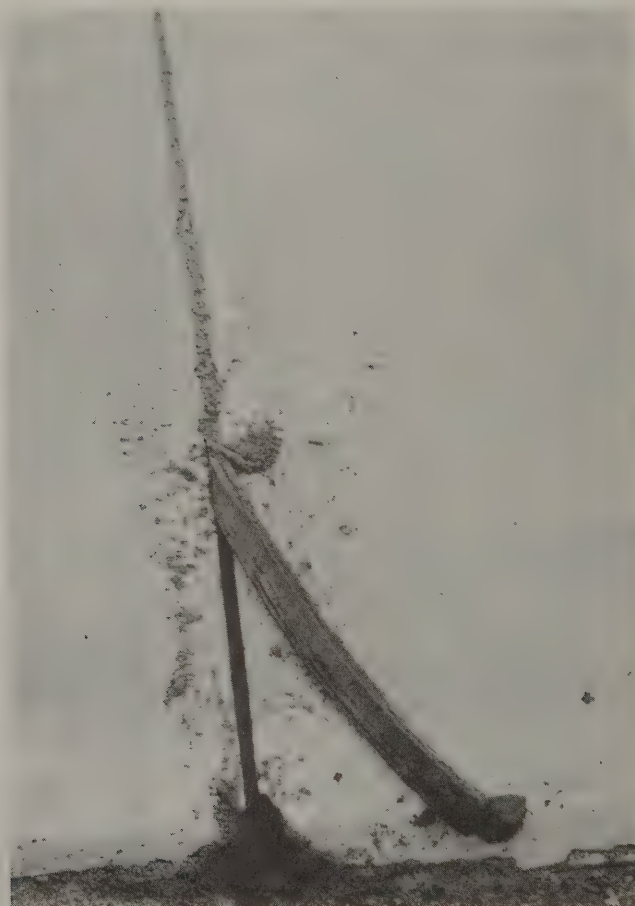
Preformed Neoprene Sealer
Compression Set Failure
Allowing The Infiltration
Of Incompressible Materials

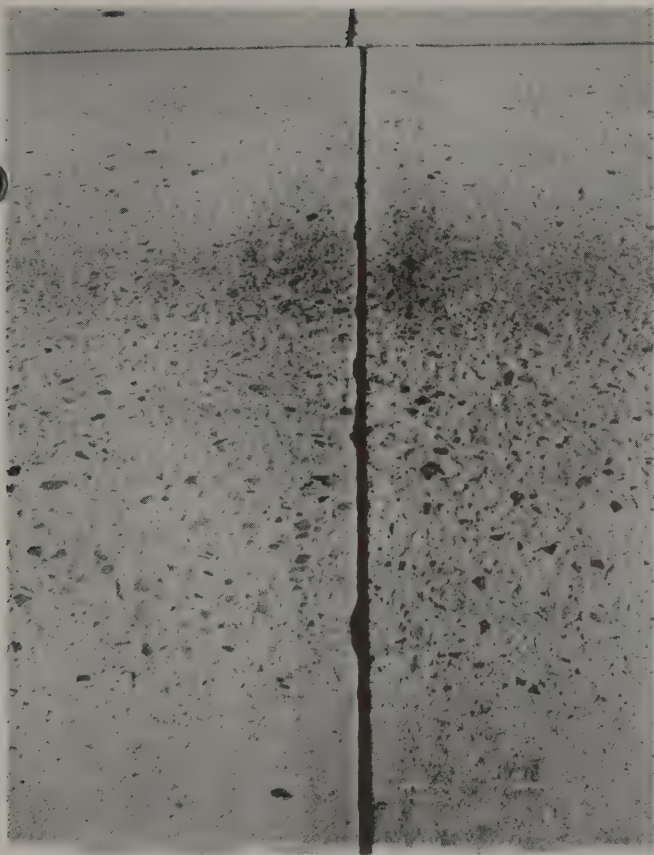
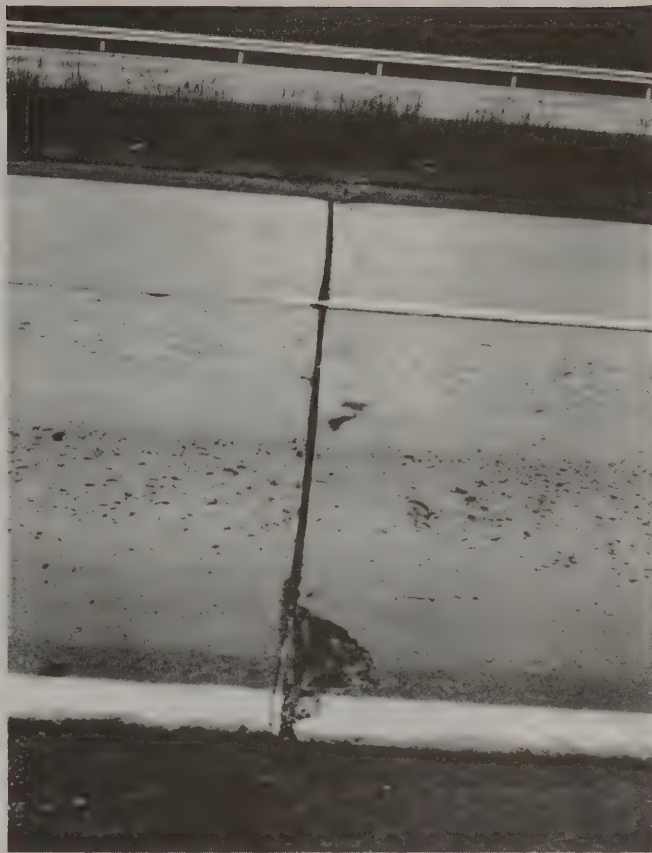
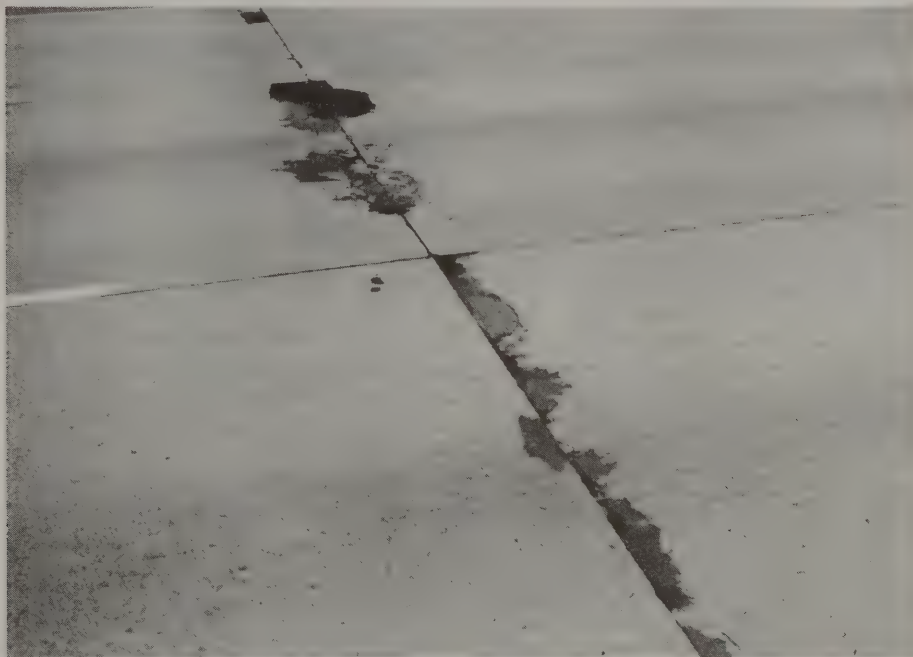
Low

Medium

High

Note the severity of wheelpath wear as shown by the varying degrees of exposed large aggregates in the three examples above.

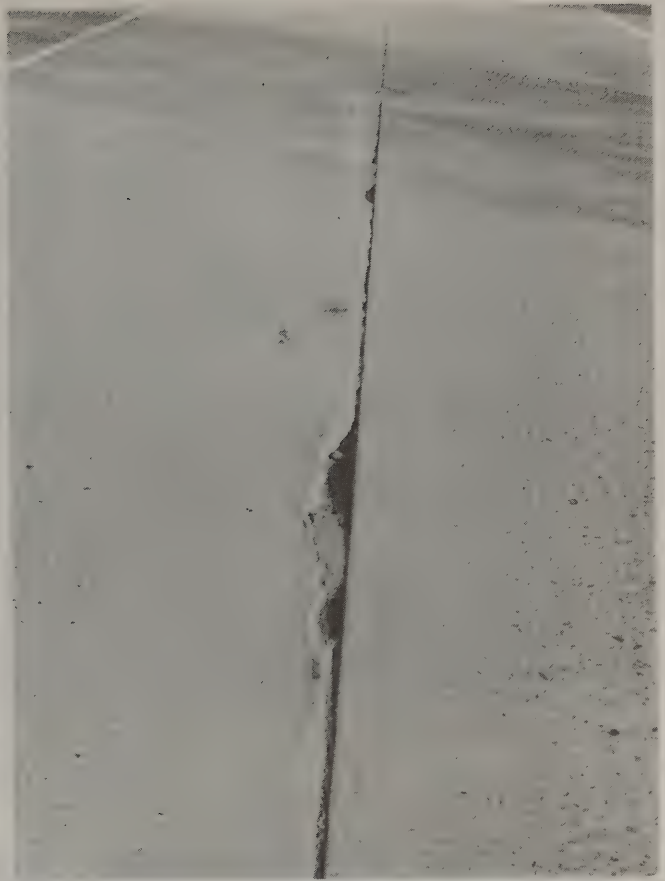
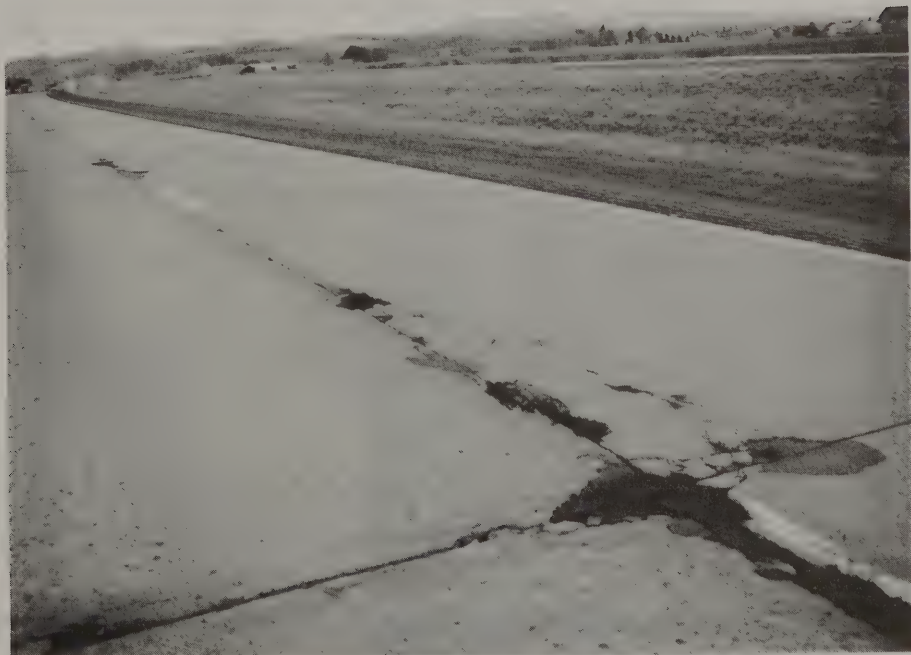
Figure B9 - Longitudinal Joint Distress

Low

Medium

High

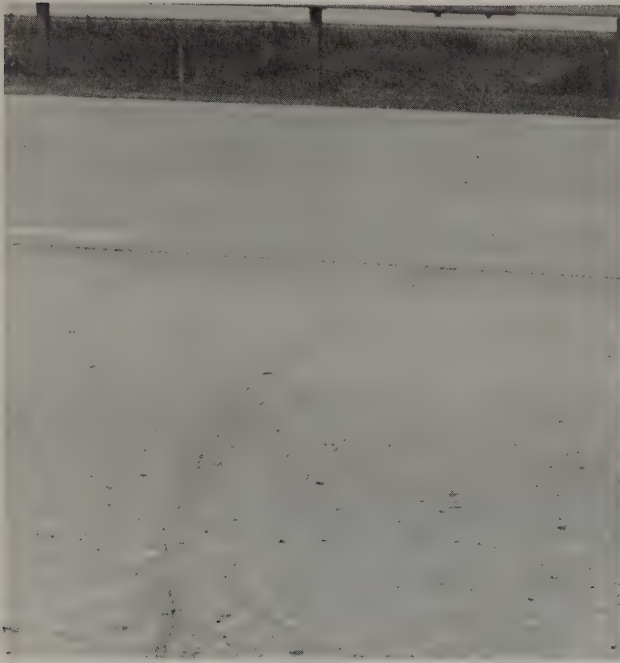
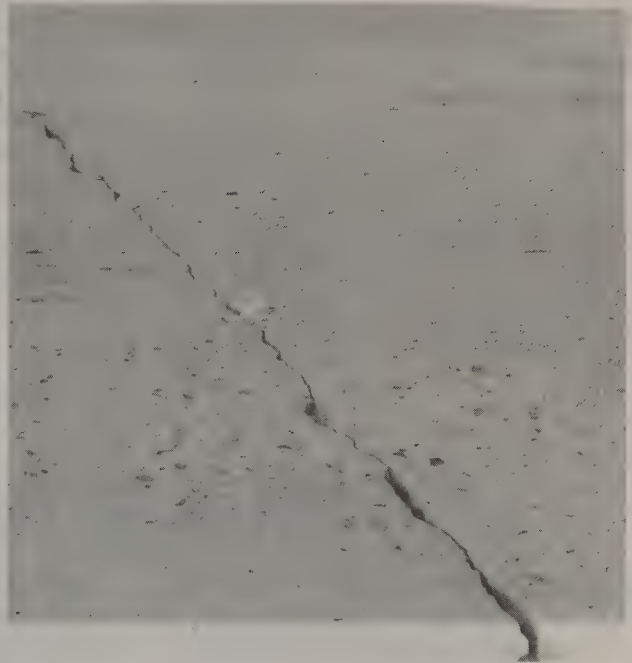
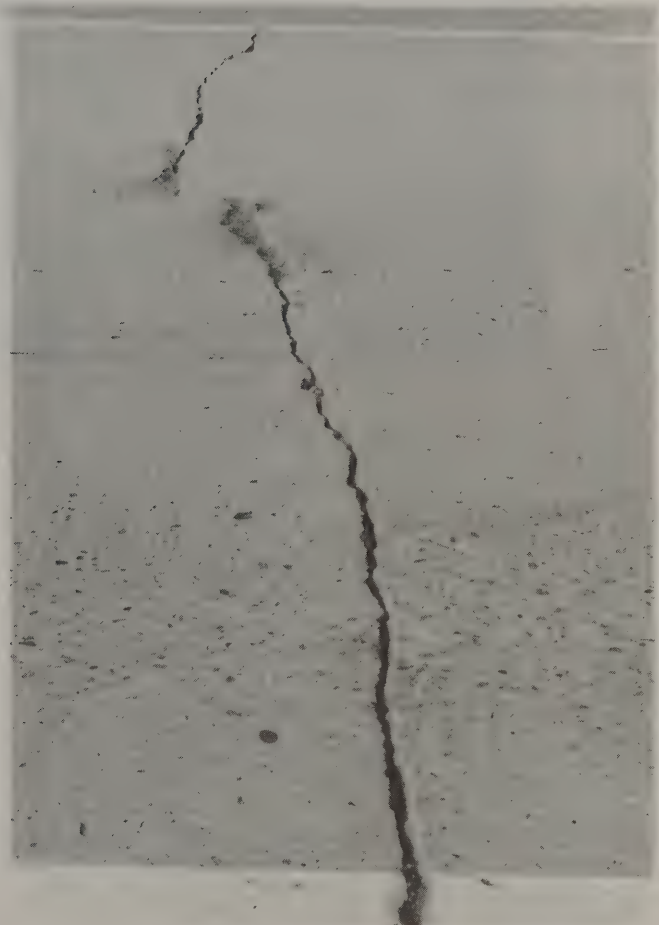
Figure B10 - Slab Cracking

Low

Medium

High

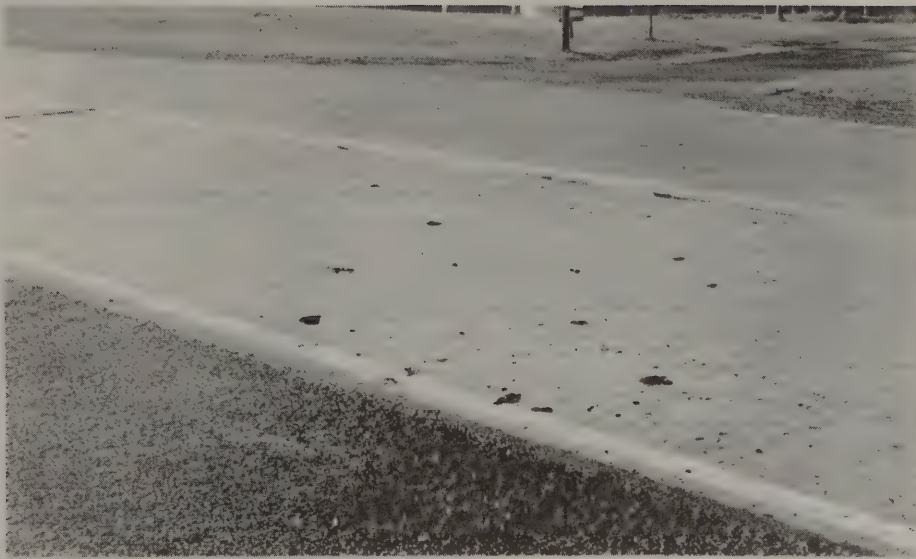
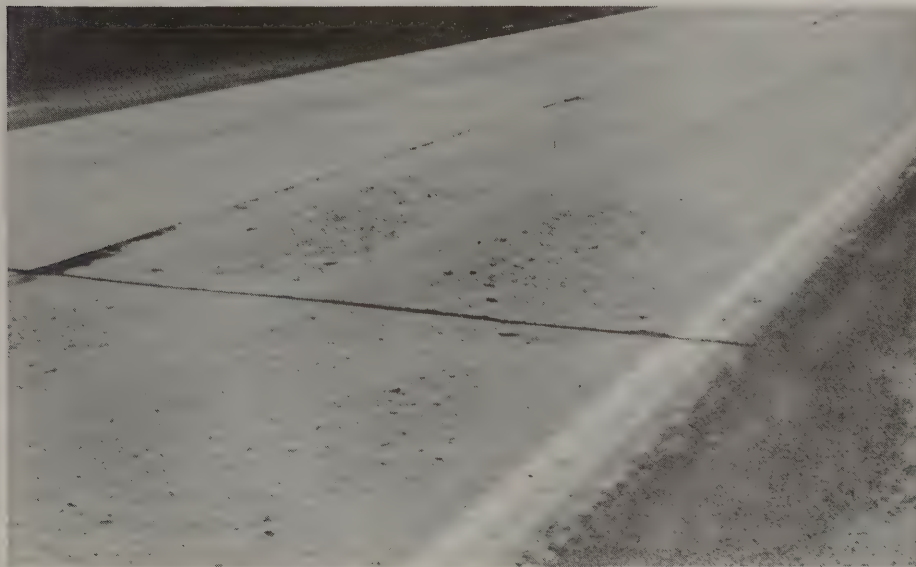
Figure B12 - Scaling Non-Joint Spalling

Low Spalling
Popouts

Medium Scaling
Showing Deterioration
Of Mortar

Heavy Spalling
Due To Corrosion
Product Expansive
Pressure And Shallow
Concrete Cover Of
The Reinforcing Mesh.

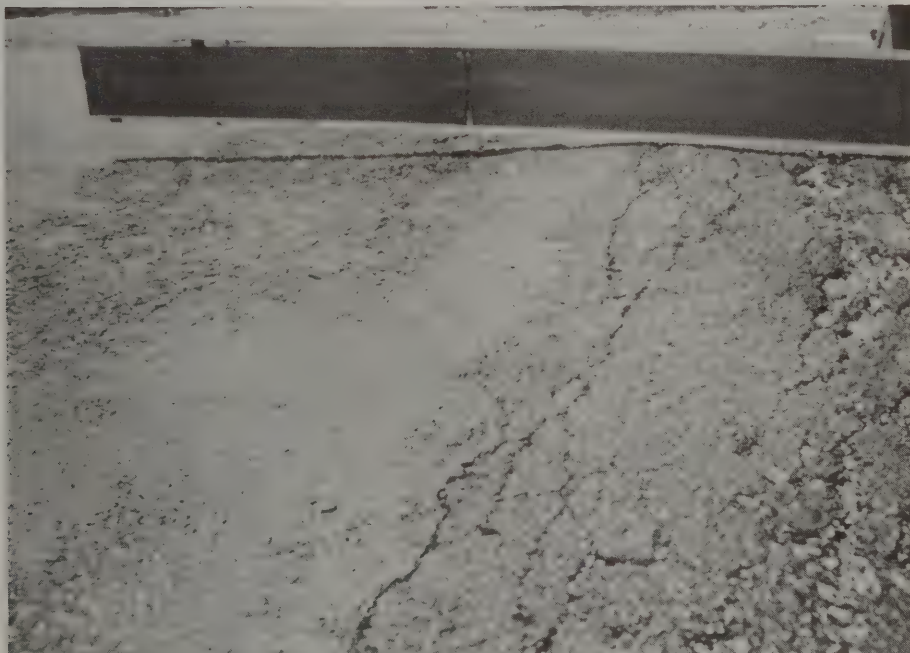
Figure C2 - Settlements And Heaves

Severe Heave

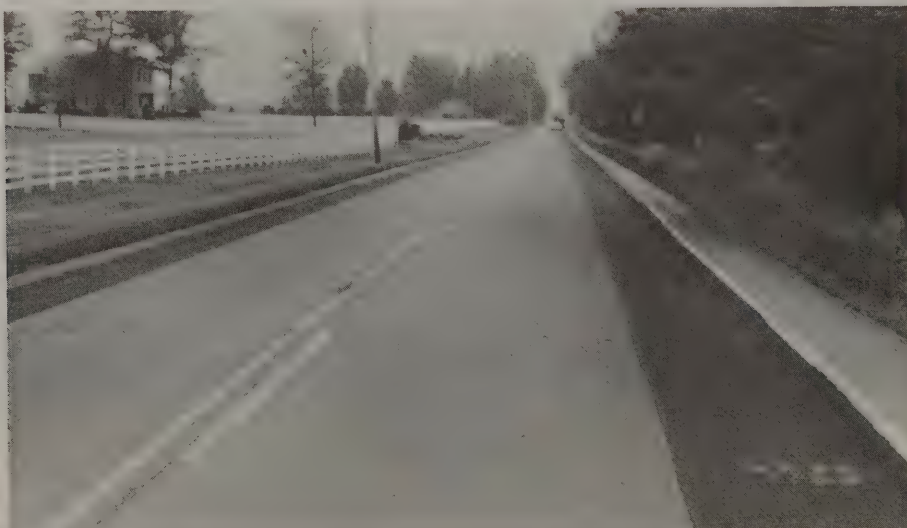
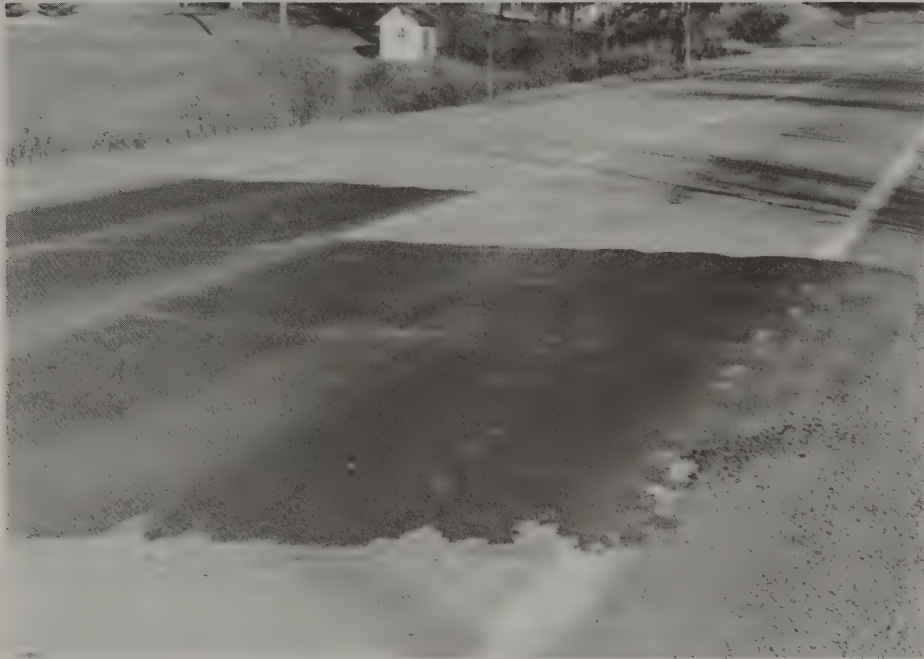
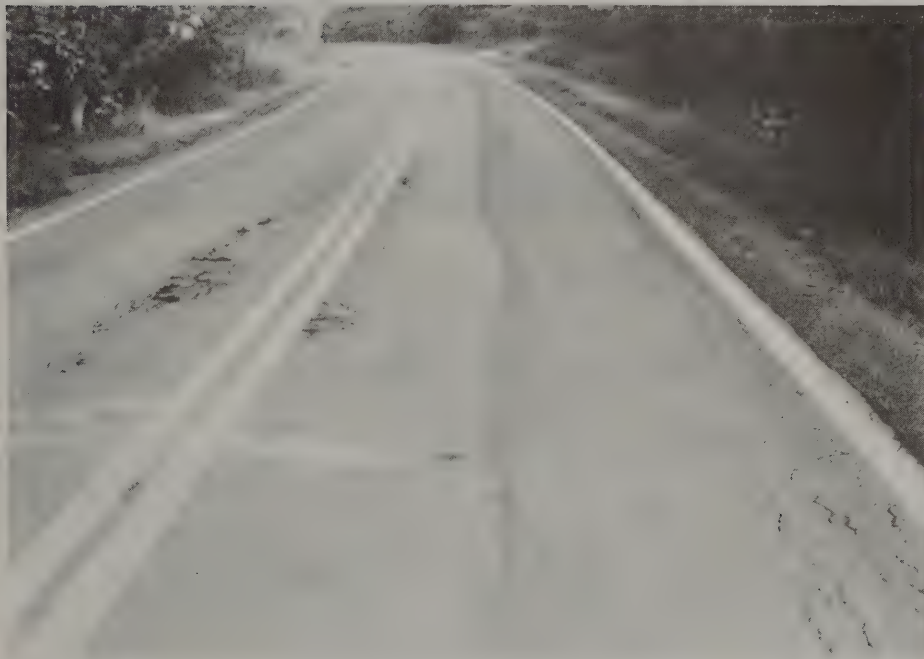
Figure C3 - Asphalt Concrete Overlay Or Spray Patch

Good

Fair

Poor

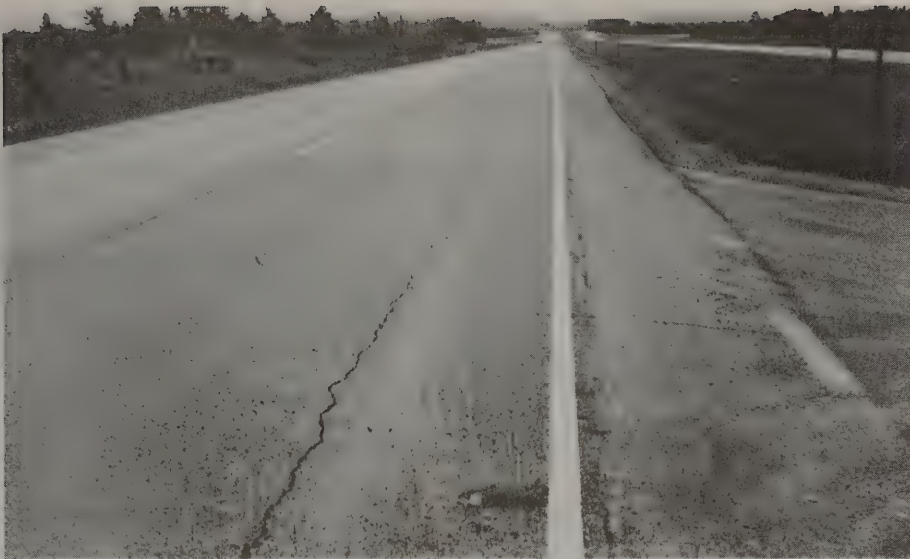
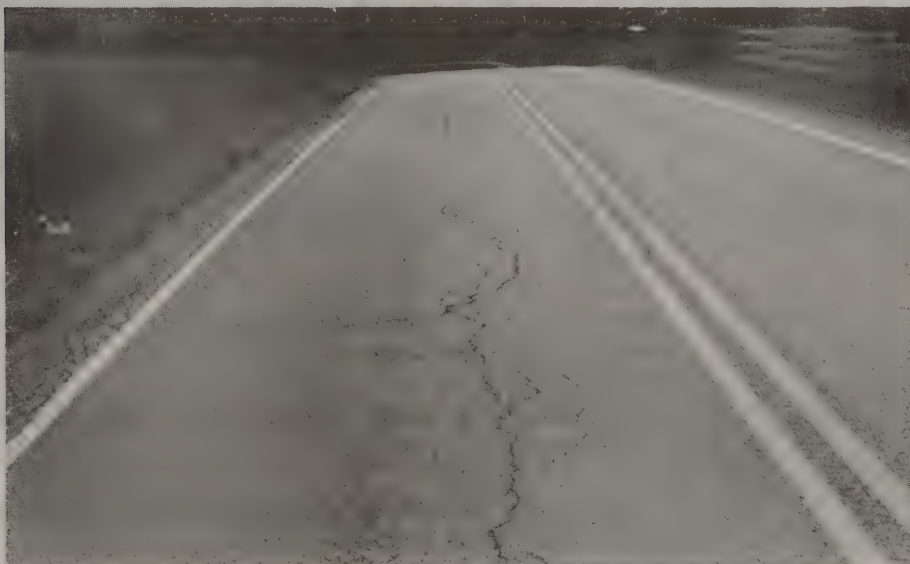
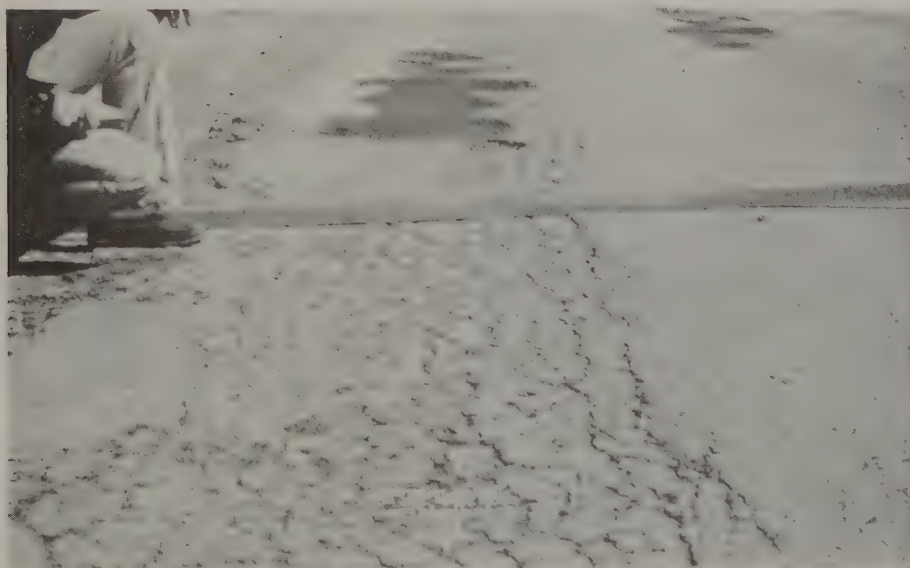
Figure C4 - Wheelpath Cracking

Low

Medium

High

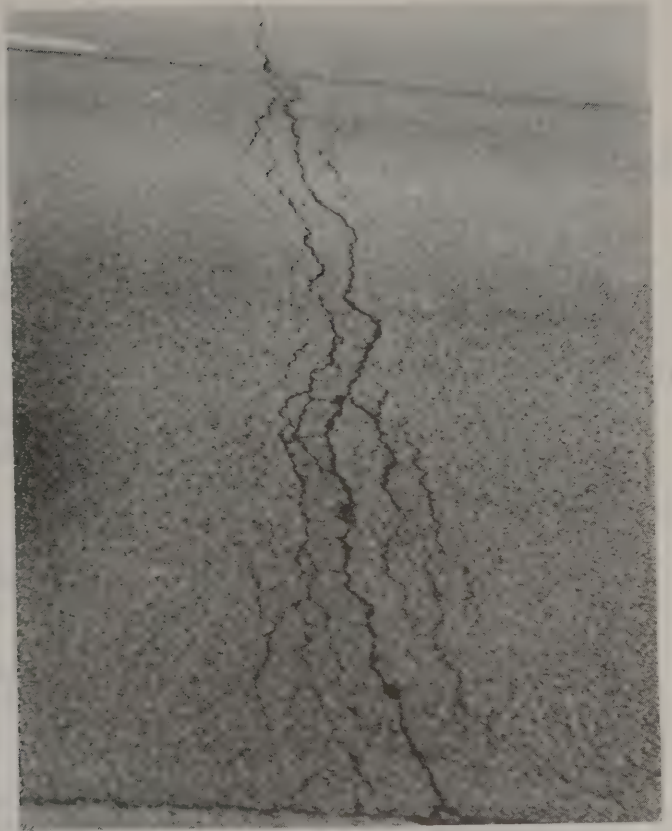
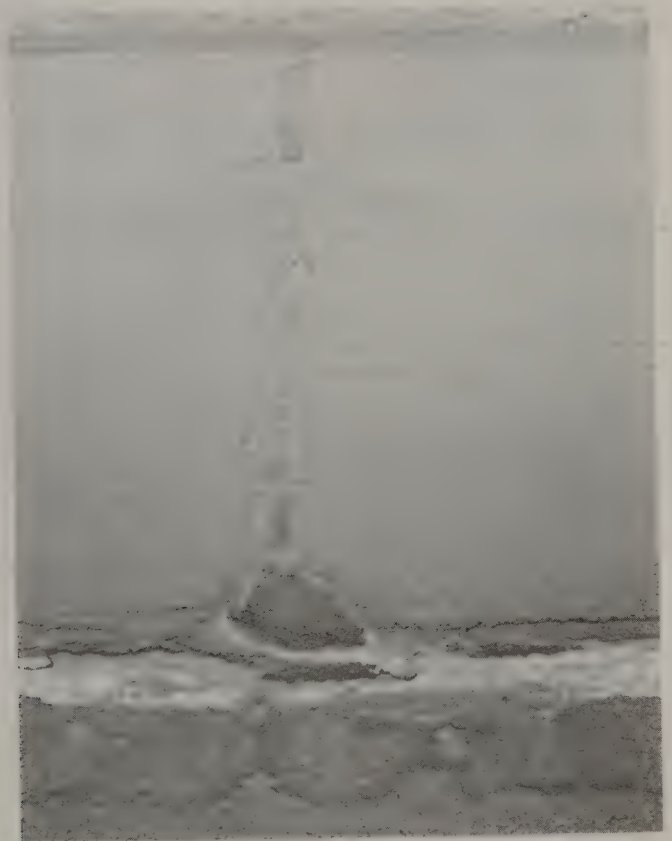
Figure C5 - Full Width Transverse Cracking

Low

High

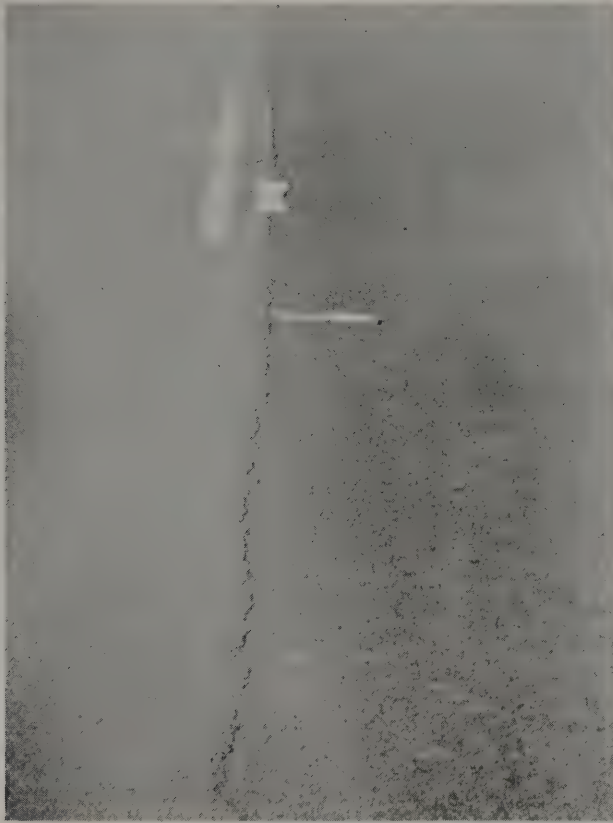
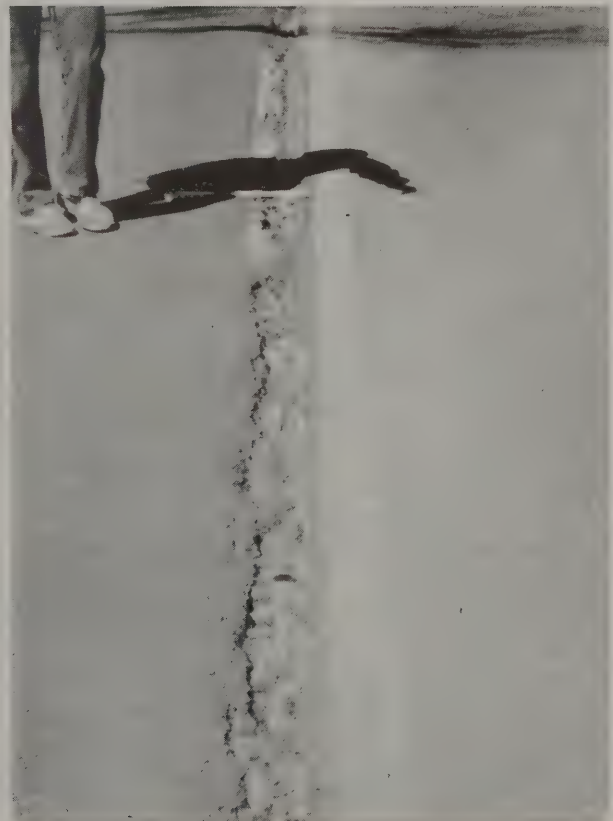
Figure C6 - Longitudinal Cracking

Low

Medium

High

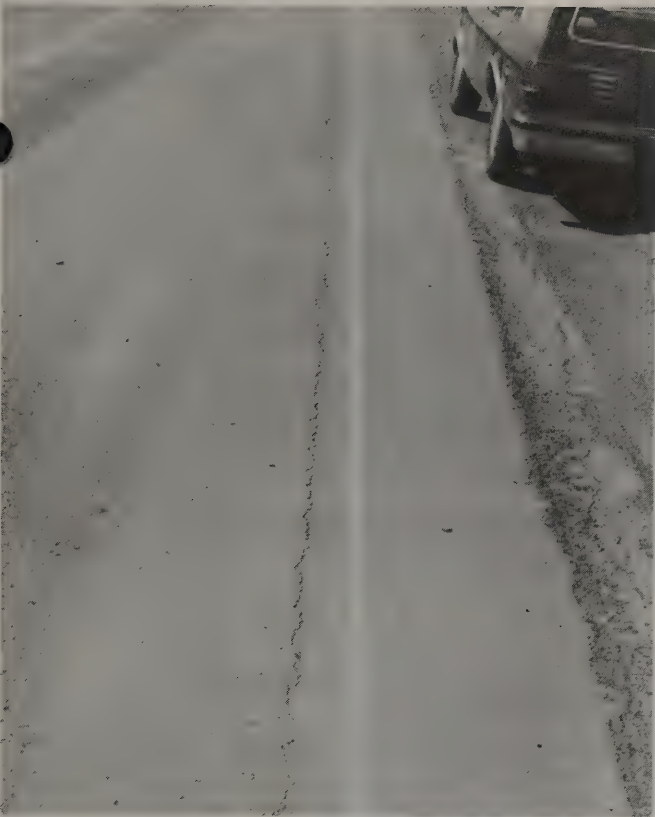
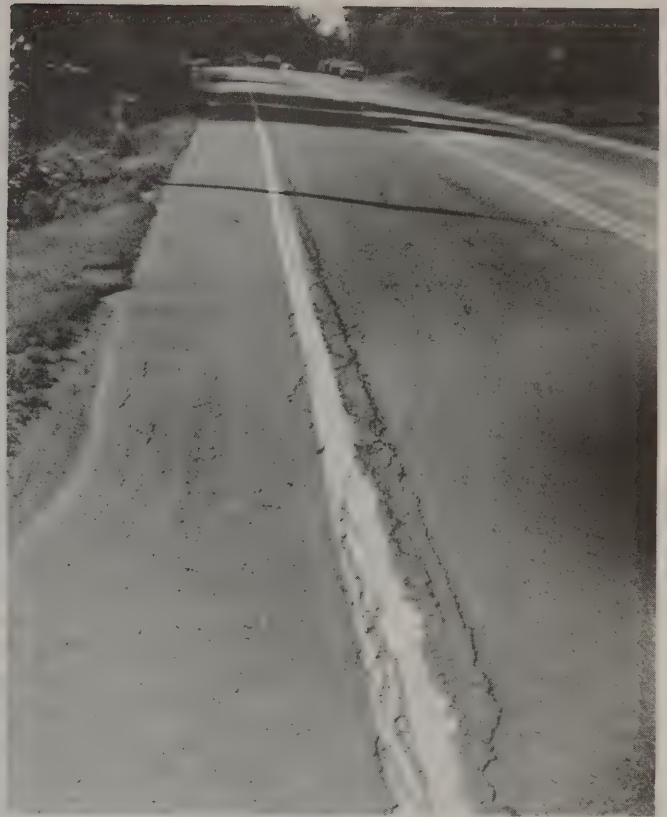
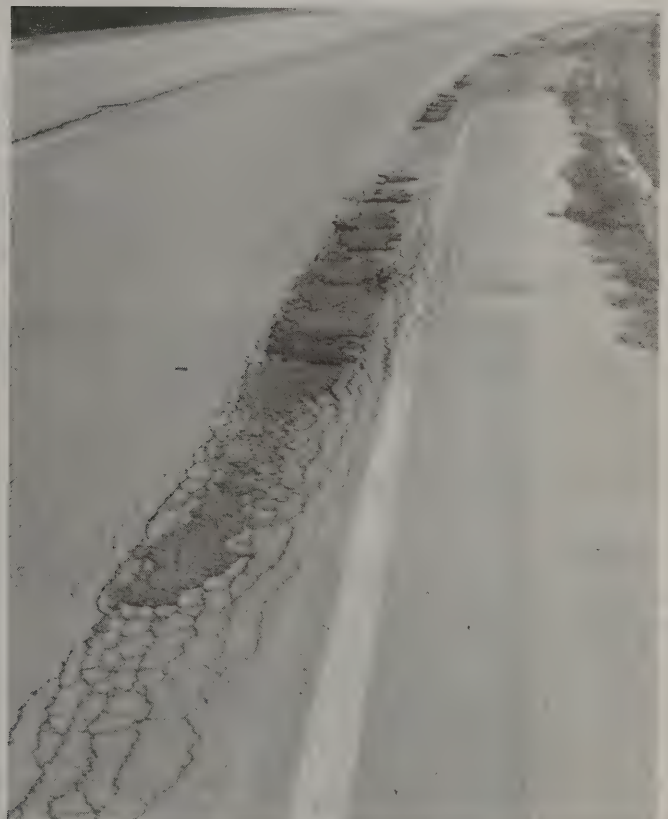
Figure C7 - Edge Cracking

Low

Medium

High

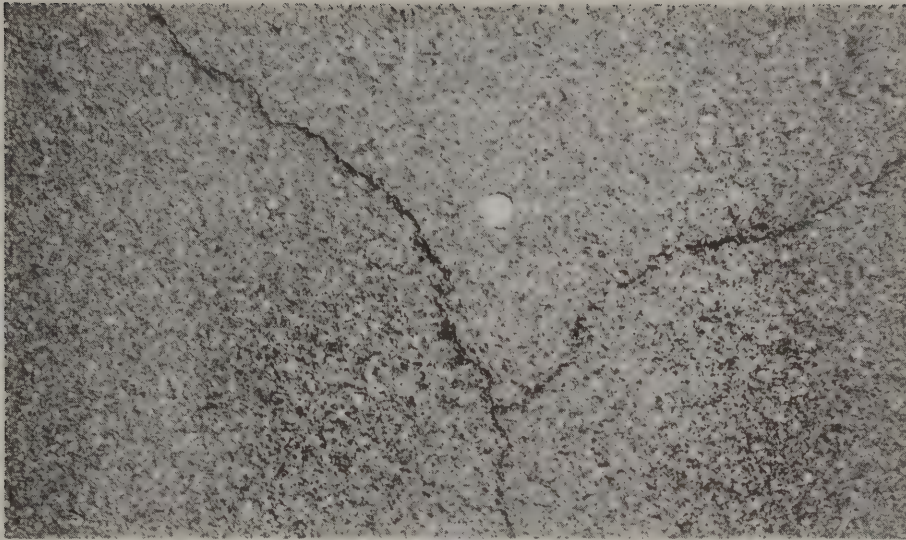
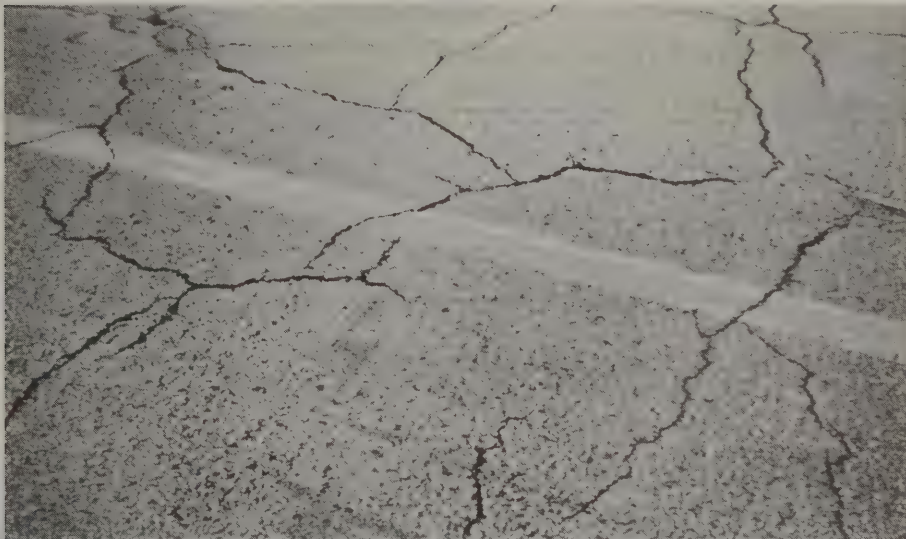
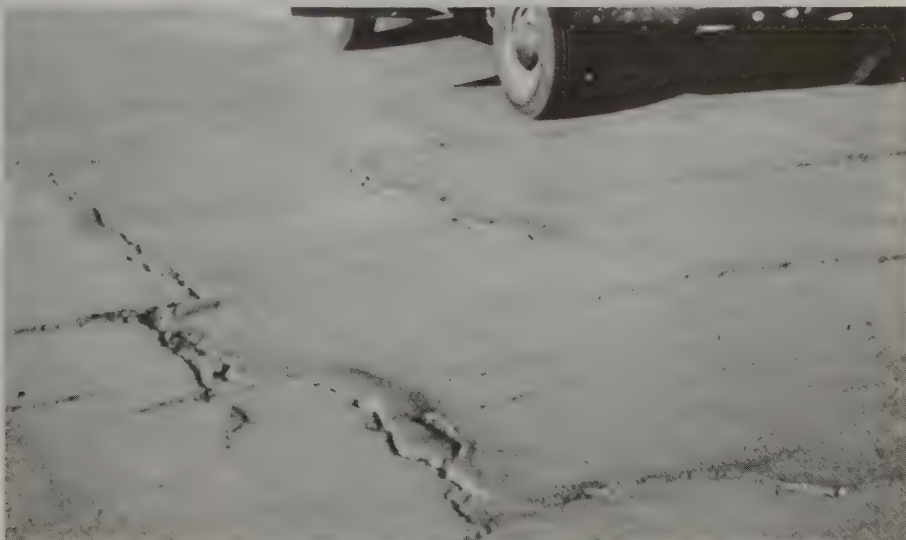
Figure C8 - Cracking (Other)

Low

Medium

High

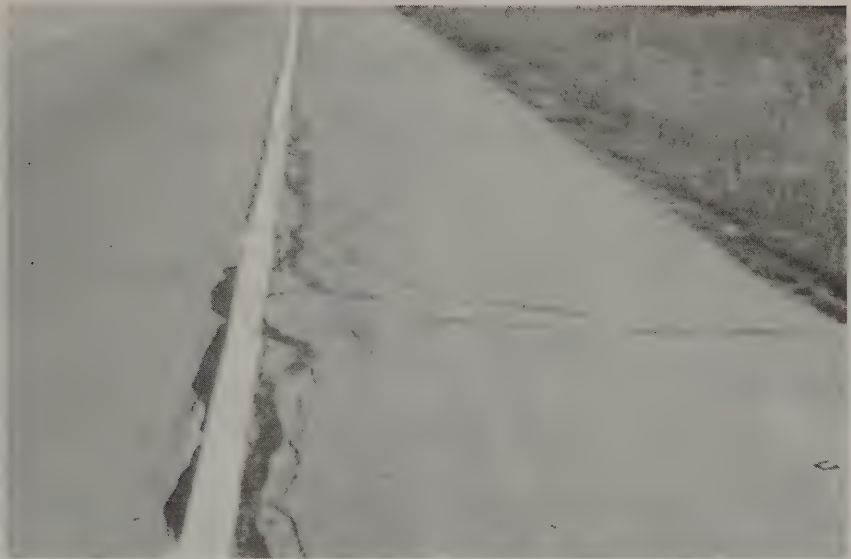
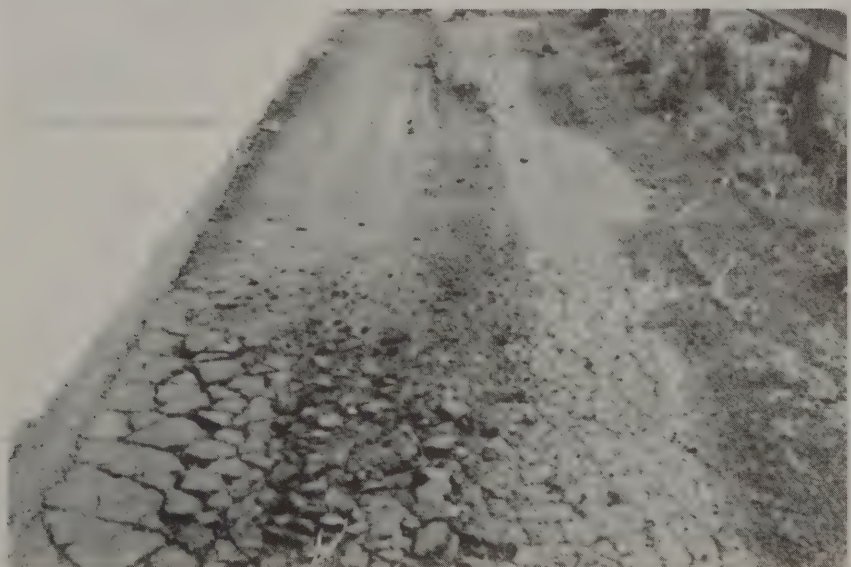
Figure D1 - Shoulder Deterioration

Low

Medium

High

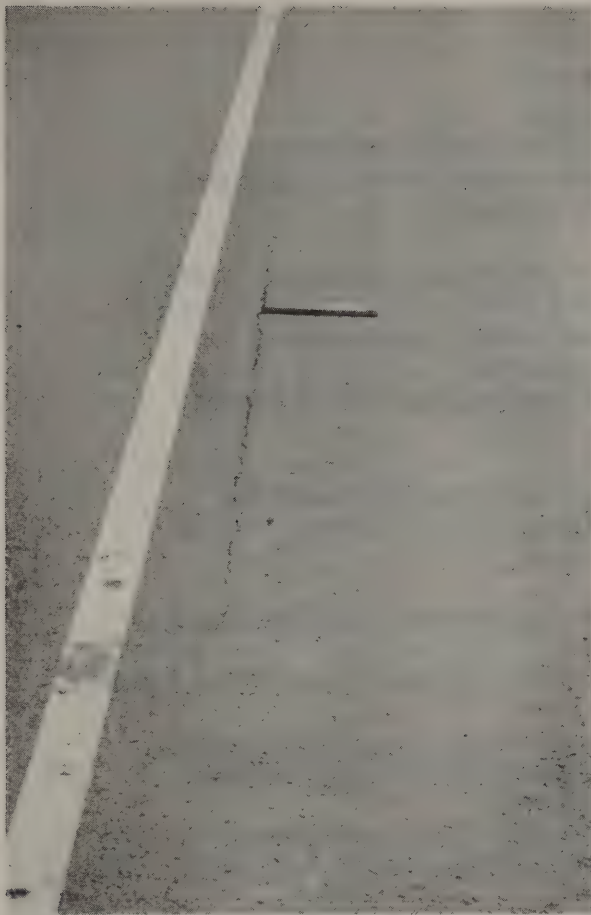
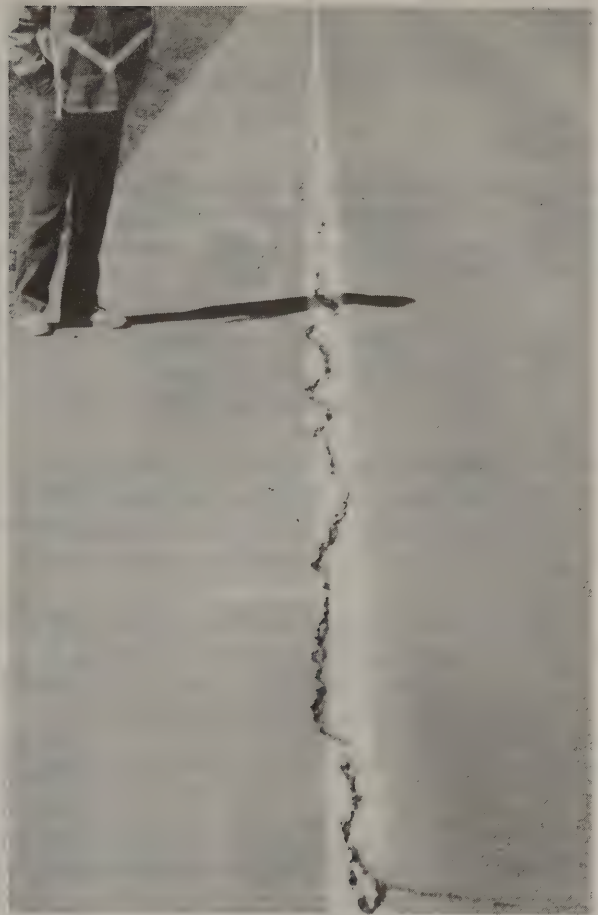
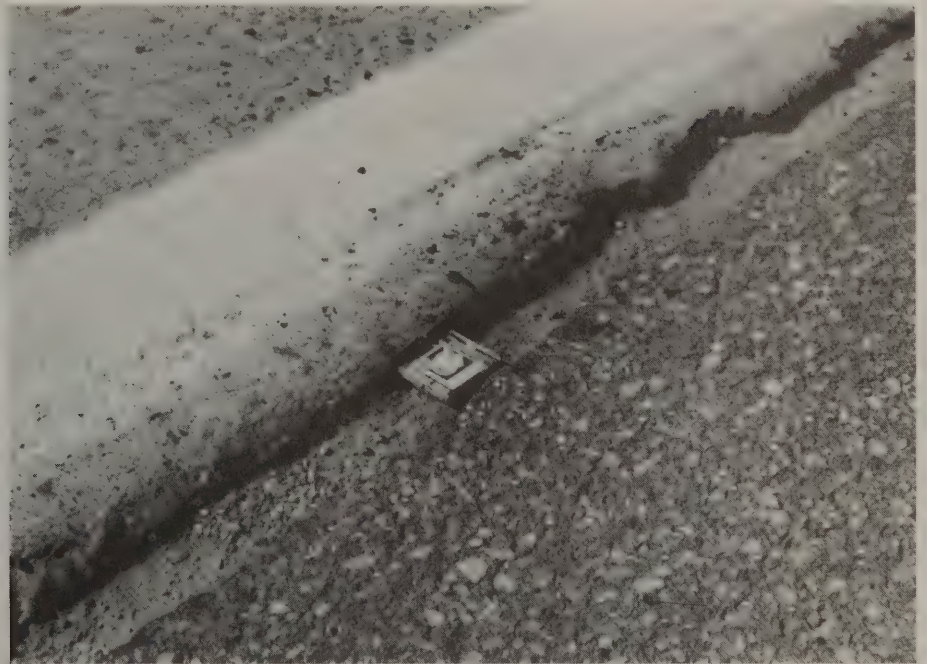
Figure D2 - Lane/Shoulder Separation

Low (AC Pavement)

High (AC Pavement)

High
(PCC Pavement)

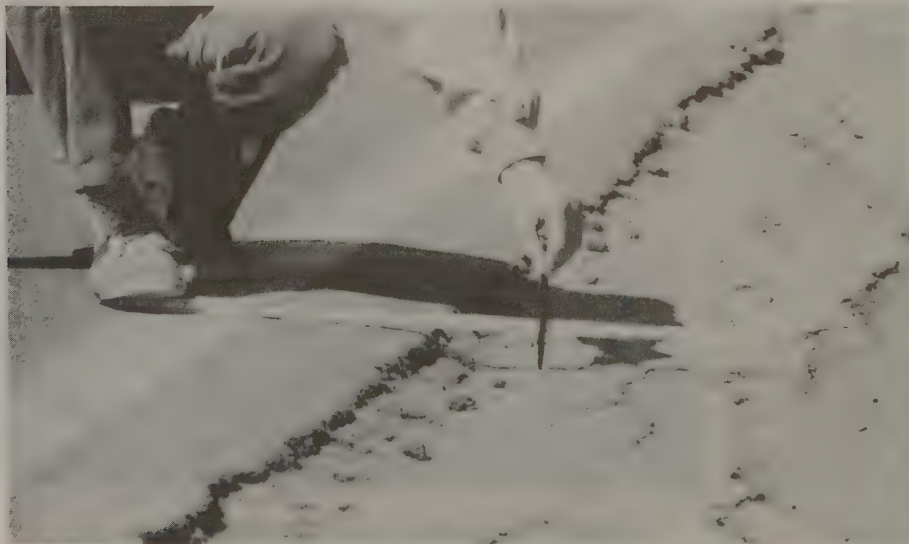
Figure D3

Lane/Shoulder Dropoff
